Fuel System - Continued

SECTION 10-VEHICLE INTERIOR

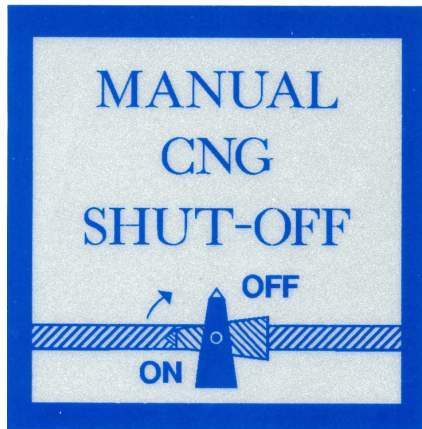
CNG manual shut-off label sample

NOTE: Each CNG vehicle shall be identified with a weather-resistant, diamond-shaped label located on an exterior vertical surface or near-vertical surface on the lower right rear of the vehicle (e.g., on the trunk lid of a vehicle so equipped, but not on the bumper of any vehicle) inboard from any other markings. The label shall be a minimum of 4.72 inches long by 3.27 inches high. Where a manual valve is used the valve location shall be accessible and indicated with the words "MANUAL SHUTOFF VALVE". (NFPA 52, 6.11.1) SEE CNG EXTERIOR AND MANUAL SHUTOFF LABEL SAMPLES BELOW.

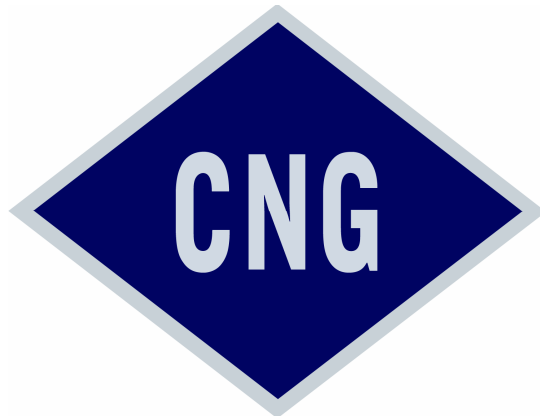
CNG exterior label sample

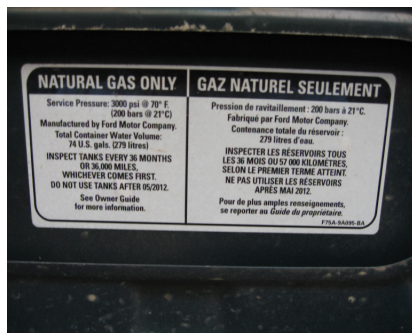
Engine Compartment Label Sample

NOTE: A vehicle equipped with a CNG fuel system shall bear a label readily visible and located in the engine compartment with identification as a CNG-fueled vehicle, system service pressure, installer's name or company, container retest date(s) or expiration date and the total container water volume in gallons. There shall also be a label located at the fueling connection receptacle with identification as a CNG-fueled vehicle, system working pressure and container retest date(s) or expiration date. If both labels are located in one of the above areas, the labels shall be permitted to be combined into a single label. (NFPA 52, 6.11)

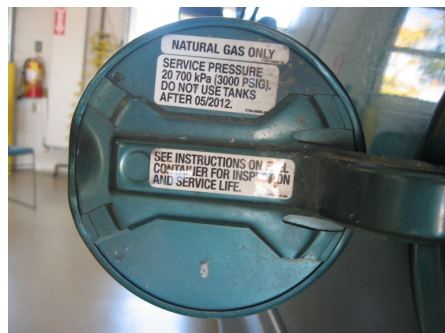
Fueling Receptacle Sample
